Low Impact Development Geotechnical Considerations that May Affect Your Project

Consultant's Corner • Fall 2010

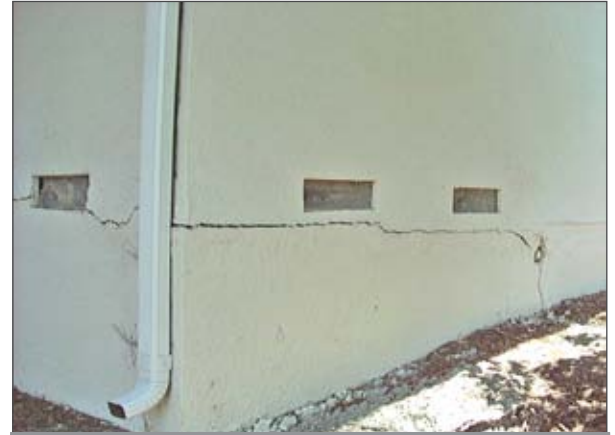
Foundation damage due to soil expansion

Features such as underground infiltration systems, above-grade basins, bioswales, and permeable pavement that involve infiltration of storm water into the soil can lead to saturation of subgrade soils below or adjacent to improvements. When soils become saturated near foundations, a number of problems can occur, such as softening of foundation support soils, hydrocollapse, or soil expansion. Foundation settlement, heaving of the foundation, or differential movement

between different parts of the foundation can be unfortunate consequences. Sloping floors, cracked slabs, broken floor tiles, cracks in foundations or walls, or difficulty in opening doors and windows can be indications of foundation problems related to saturated soils. Musty odors, mildew or mold can develop when soils beneath a building become saturated or where there is standing water.
