Consultants Corner

Testing the Limits of High-Rise Construction

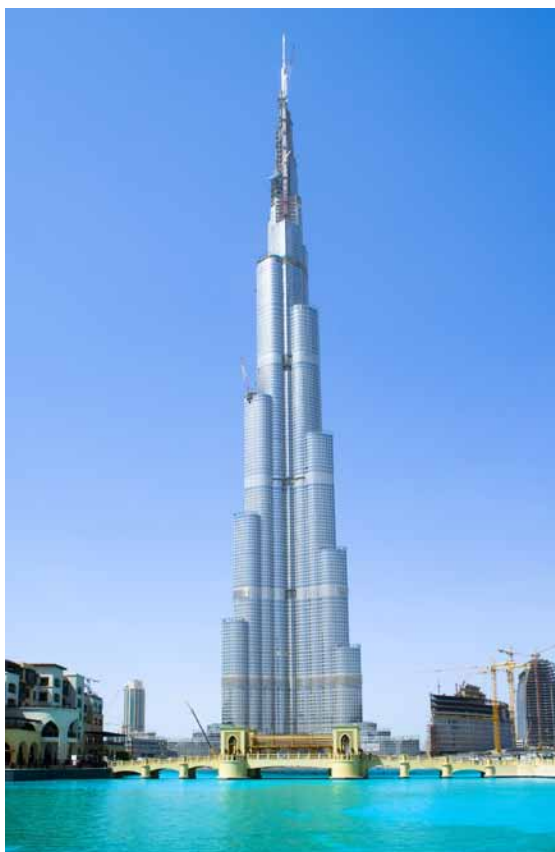
Burj Khalifa in Dubai, UAE, the world's tallest building.

The world's tallest skyscraper opened on January 4, 2010 in Dubai, United Arab Emirates. With 162 floors and a height of 2,717 feet, Burj Khalifa surpasses the previous record holder, Taipei 101 of Taiwan, by more than 1,000 vertical feet.

Designing and constructing a building of such extraordinary height involved numerous technological challenges, particularly in view of the climate and soil conditions of the Persian Gulf. Support of the building was accomplished by constructing 192 concrete piles that extend 164 feet into the underlying sandy soil. With its slender silhouette, swaying of the structure due to wind stress was a significant design concern. During the design process, the building was rotated 120 degrees from its original position to accommodate the prevailing winds. At its tallest point, sway of the tower is estimated at 3.9 feet.

Like most modern skyscrapers, Burj Khalifa is built of reinforced concrete and composite construction materials rather than traditional steel. As construction progressed, the difficulties of pumping thousands of cubic yards of concrete to the required heights had to be overcome. Special mixes of concrete were developed that had both the necessary consistency to be pumped to extreme heights, and the ability to withstand the extreme stresses imposed by the massive weight of the building.
